# **Extreme Loading® for Structures**

**Version 3.1**

Corrosion Effects Option

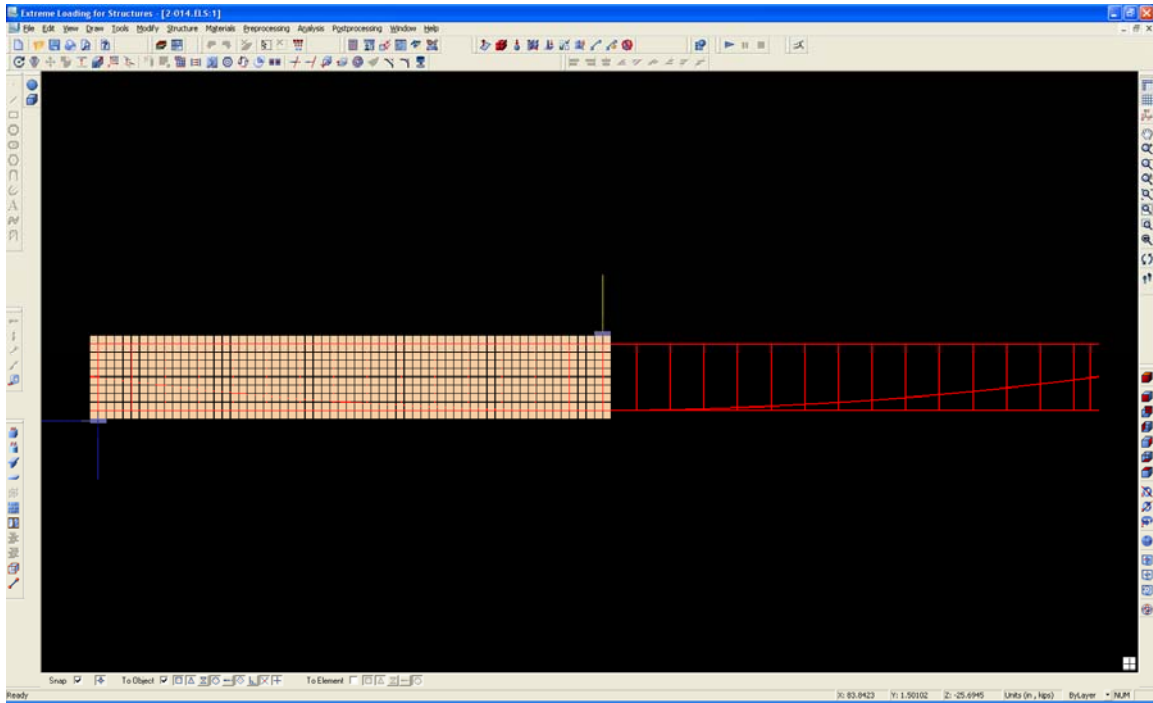
Fig. 1 shows a simply supported pre-stressed beam subjected to a 3 point loading [Ref. 1]. Dimensions and loading setup are shown in Fig. 1. Fig. 2 shows the ELS model for the girder where half the girder is hidden to show the reinforcement and pre-stressed tendon inside the model. A pre-stressing Force of 40.5 kips (180 KN) was applied to the tendons.

**Fig. 2 ELS Model**

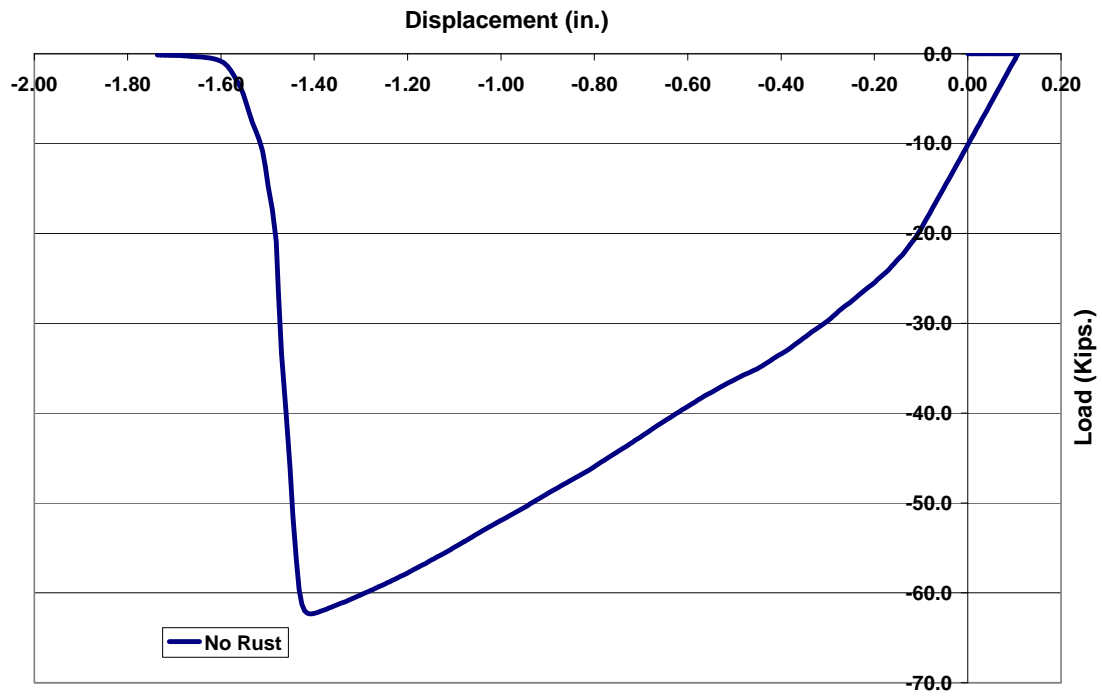
**Fig. 4** Load Deflection Predicted by ELS

The analysis is performed using two loading staged. In the first stage, the own weight and pre-stressing forces are applied in 10 increments to follow possible cracking and nonlinear behavior in this stage. Then in stage II, the concentrated load is applied as incremental displacement load at the center of the girder as shown in Fig. 2. Fig. 3 illustrates the Moment-Deflection analytical results compared to the experimental ones. As can be seen, the results are close to the experiments. Fig. 4 shows the load deflection curve where it can be seen that the failure load recorded was 61 Kips. Referring to Fig. 4, the girder first deflected upward due to the pre-stressing forces then it started deflecting downward when the concentrated load was applied. The behavior is well predicted in the elastic stage and in the post cracking stage. Fig. 5 shows the calculated principal strain contours. The principal strains represent a good, obvious representation of crack localizations. Fig. 6 shows the observed experimental cracking pattern of the beam. The experimental cracks are generally in a good agreement with the ELS results. It should be noted that the cause of failure is a compression failure happened near the loading point as shown in Fig. 7

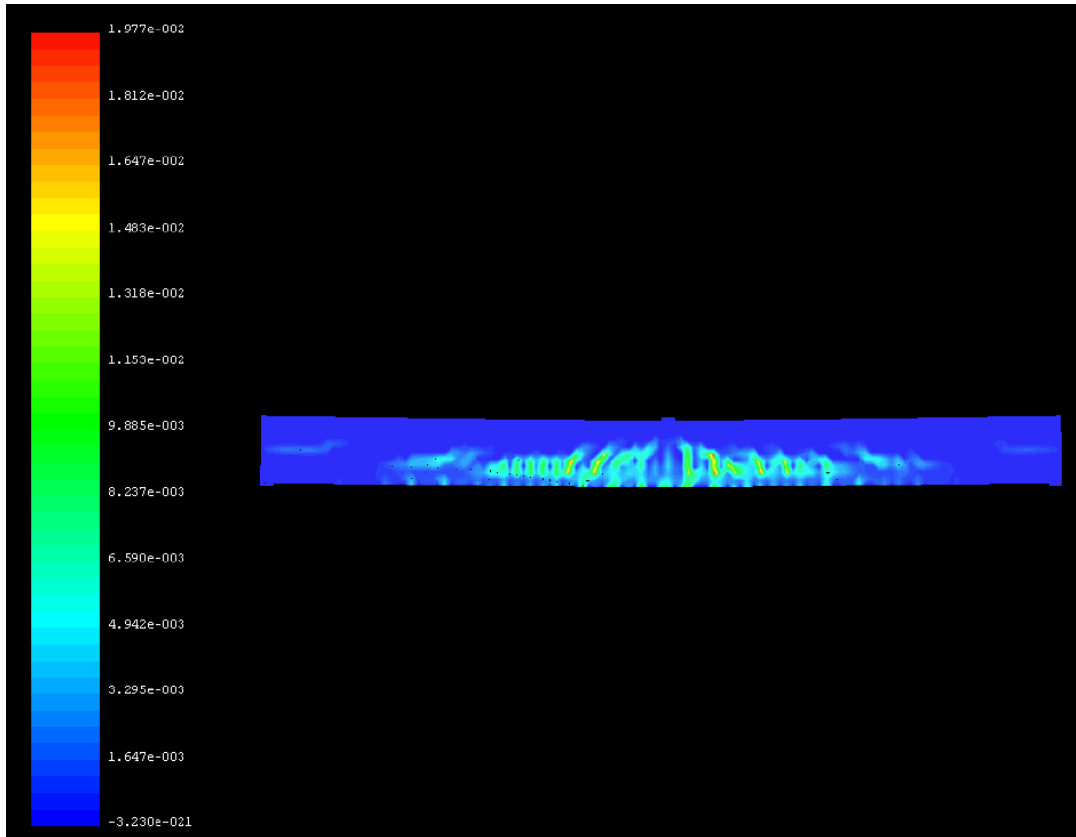
**Fig. 5** Principal strain contours predicted by ELS

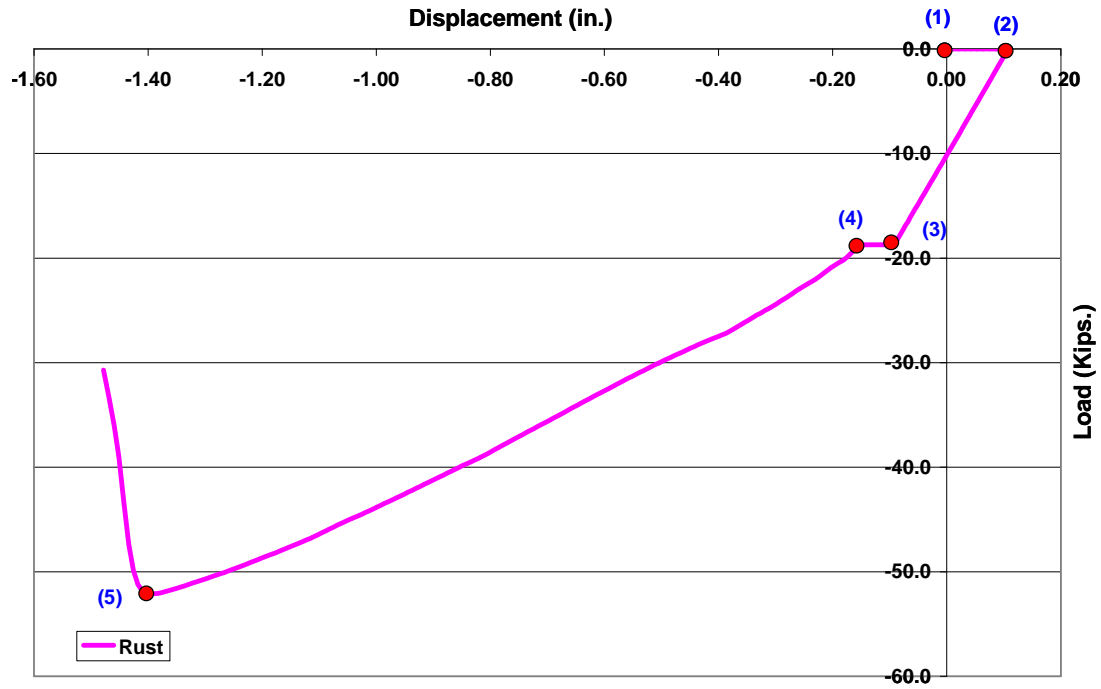
Fig. 8 shows the load deflection curve for the girder after applying rust on the pre-stressed tendon by 25% which means that the area of the tendon was reduced by 25%. This load deflection curve passed through different stages. From point (1) to point (2) the own weight and the pre-stressing force were applied. At point (2) the loading begin to increase incrementally until it reaches point (3) where the rust begins to appear. The rust (area reduction) was applied from point (3) up to (4) by gradually reducing the rebar area in 90 steps. Then the loading was increased incrementally until the girder reaches its ultimate capacity and failed at load 51Kips. A compression failure also occurred in this case as shown in Fig. 9. Fig. 10 shows a comparison between the load deflection before and after applying rust. It is clear that the rust caused decrease in the load carrying capacity of the section which leads to early failure.

Fig. 8 Load Deflection Predicted by ELS

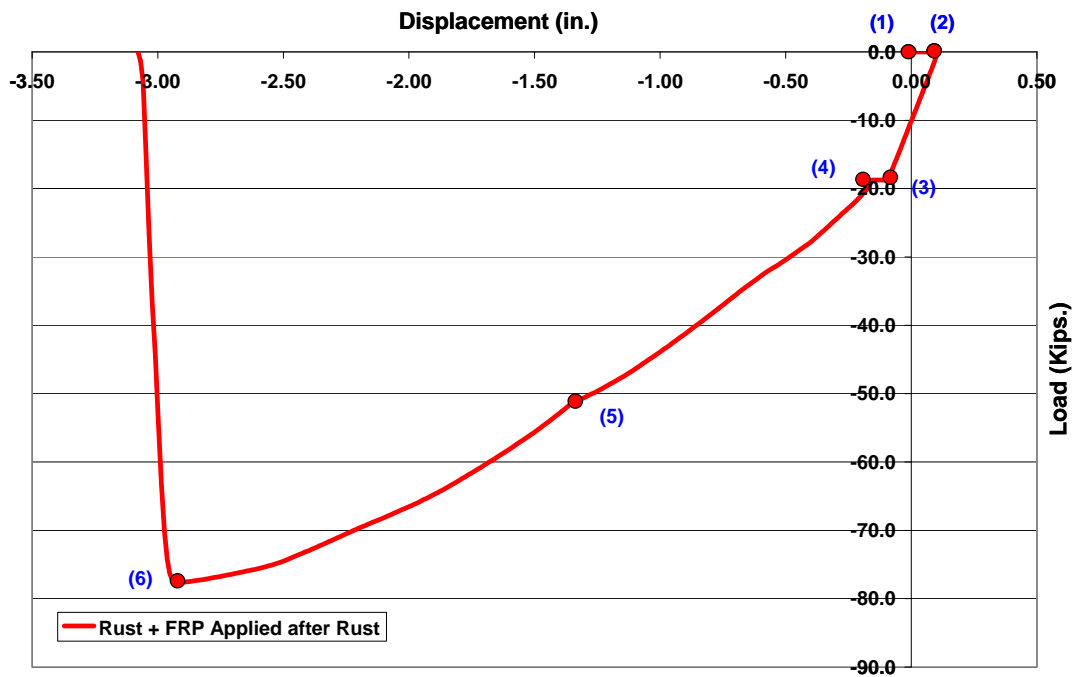
- 1- Apply own weight and pre-stressing loads (Segment 1-2 at Fig. 12 below)
- 2- Then loads will be applied to the girder (Segment 2-3)
- 3- Then the load will be kept constant and the rusting will be applied to the rebar (Segment 3-4). The girder deflection increases due to rust while the rust is applied.
- 4- Then the load is applied again to the rusted girder (Segment 4-5)
- 5- Before reaching the failure load, the girder will be retrofitted with FRP plates having a thickness of 0.5mm on both sides of the girder as shown in Fig. 11.
- 6- The load is applied again until it reaches the ultimate capacity of the section at about 80Kips (Point 6).

**Fig. 12** Load deflection curve for Girder Retrofitted by FRP Plates

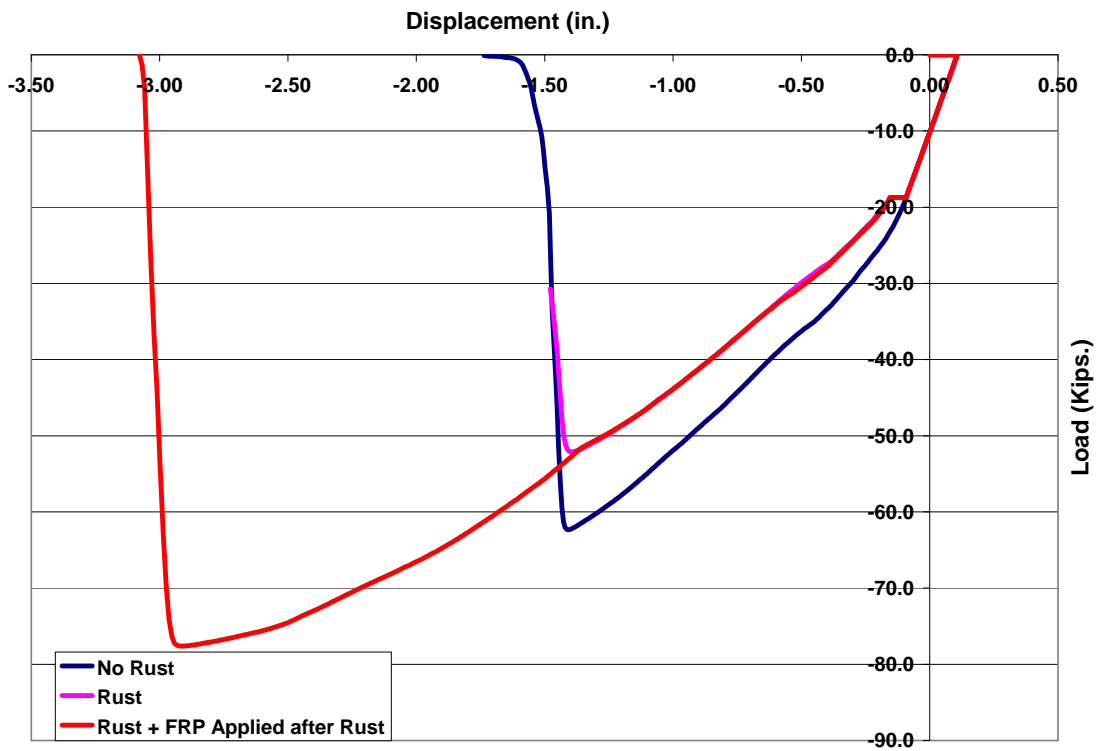
Fig. 13 shows the failure of the retrofitted girder. Fig. 14 shows a comparison between different rusting cases.

Fig. 14 Comparison between different rusting cases

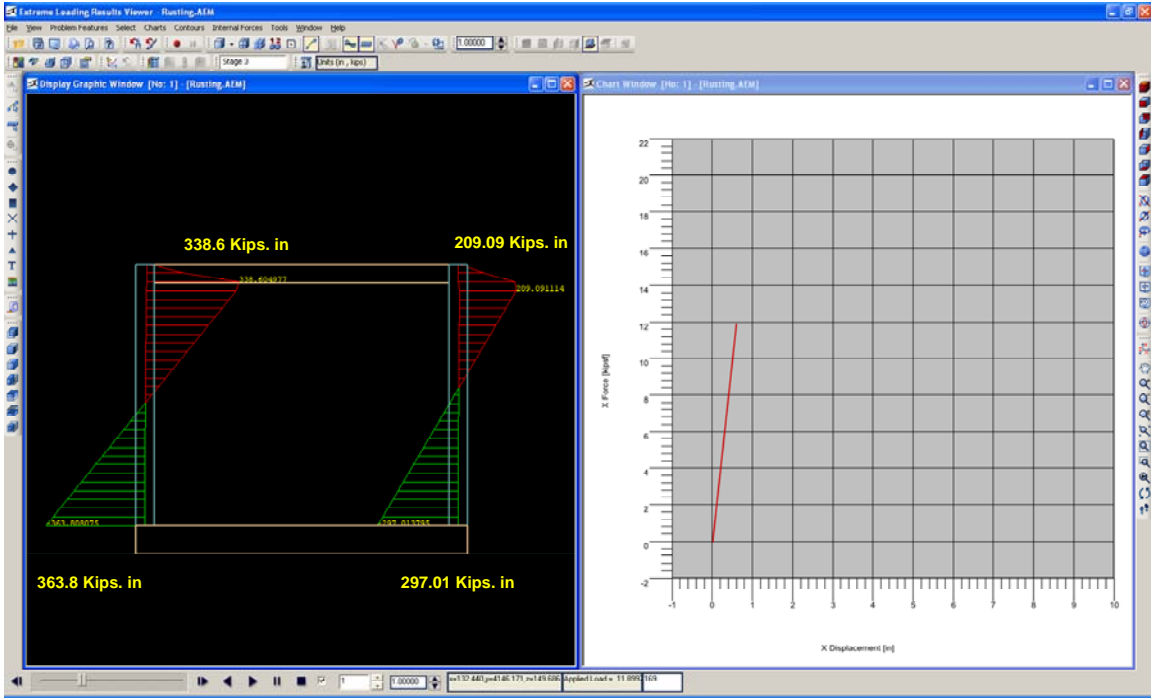
- 4- At point (3), the load begins to increase incrementally until the analysis stops at point (4). Fig. 21 shows the B.M.D in the columns at point (2) while Fig. 22 shows the B.M.D in the columns at point (3). Fig. 23 shows the B.M.D at point (4). Note that the bending moment values decreased due to rust from point (2) to Point (3) then it increased again until point (4).

Fig. 21 B.M.D at point (2)

Fig. 24 shows the moment deflection curve at the rusted connection predicted by ELS. It is clear that the bending moment reduced from point (2) to point (3) where the rust effects ends while the displacement kept increasing. Referring to Fig. 21 and Fig. 22, the bending moment at the lower rusted connection is reduced due to rust effects while the bending moment at the top un-rusted connection increased since the lower connection becomes weaker. Fig. 25 shows a compression between the load deflection curves ELS results without rust and ELS results with rust.
